**SAS Superstructure**

Daily Diary Report by Bid Item

Contract No.: 04-0120F4

Diary #: 094 Const Calendar Day: 21 Date: 25-Jun-2012 Monday

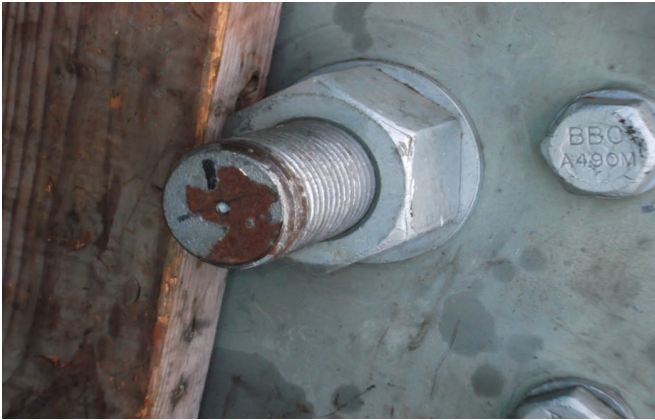
Rust-Tower Saddle-GalvanizedBolts

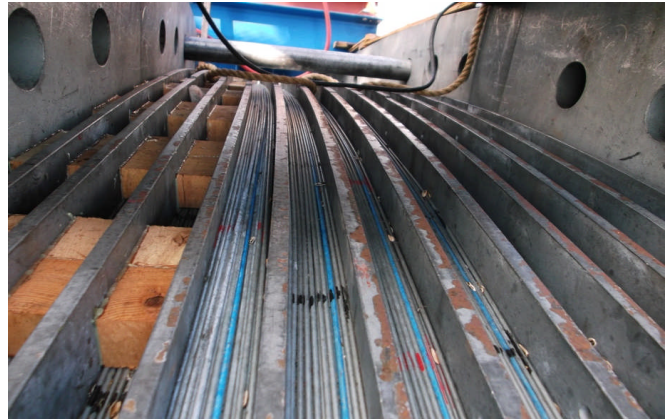
At about 9:30, Jim & I headed up to the Tower saddle to check out the damage to the bolt holes for the tie rods. Bob Brignano had told me that these holes need to be fixed as ABF is going to install the tie rods in the near future. The more shocking damage at this location was to the tops of the divider plates and not the bolt holes as galvanizing on the tops of almost all divider plates had chipped off and rusted. Attached, there are photos showing the damage to the bolt holes and the tops of the divider plates. I called Andy Castaldi with this news and asked him to check the urgency of this issue and determine a suitable time to repair the damage.

Rust-Tower Saddle-Divider Plates

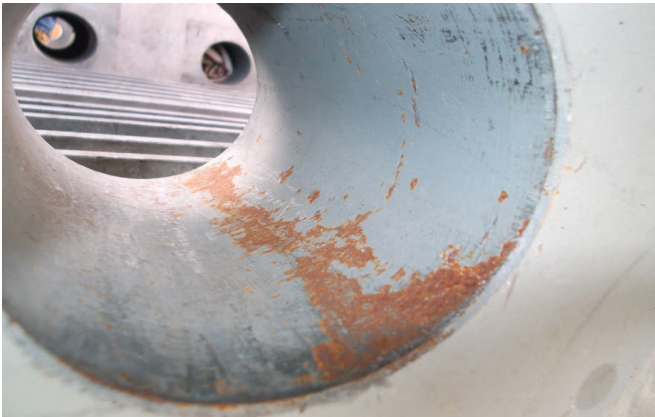
Rust-Tower Saddle-TieRod Holes

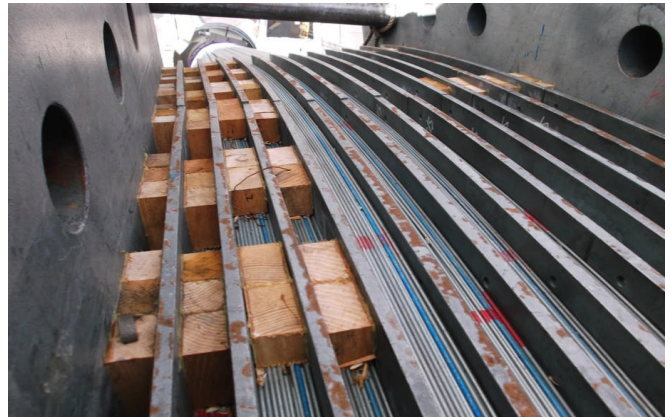
Rust-Tower Saddle-Divider Plates (2)

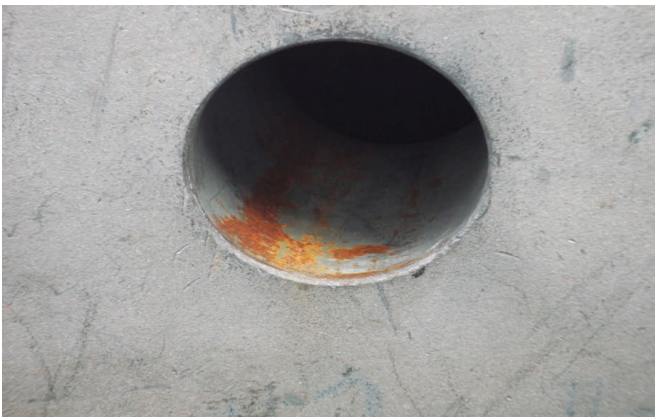
Rust-Tower Saddle-TieRod Holes (3)

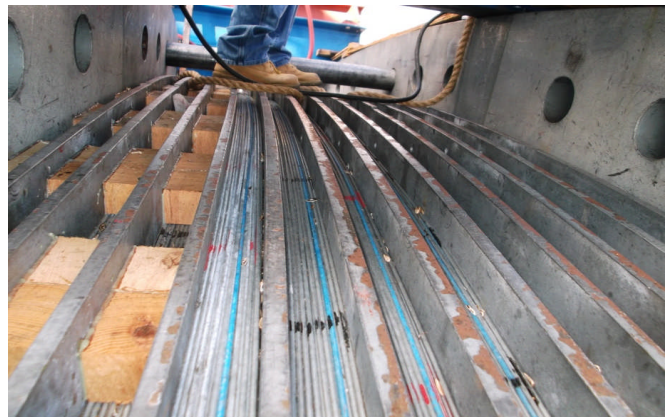
Rust-Tower Saddle-Divider Plates (1)
